Manhole Inspection Summary

Manhole # S13CC_003MH

Location Address: **2901 WINCHESTER ST**

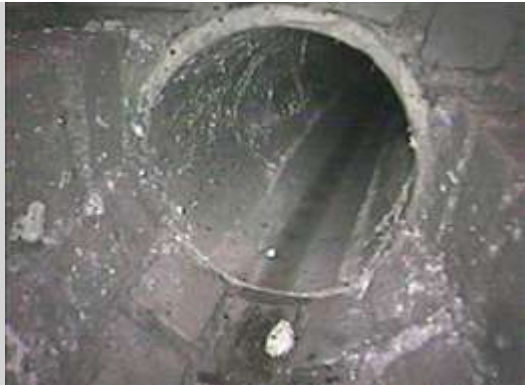
9 O'Clock Inflow

Pipe Height: (in.) Direct

Pipe Material: **Clay** ☐ Pipe Lined

Infiltration: **None** Pipe Seal Cond: **Sound**
